Rust, Weathering and other considerations

by Art Braunschweiger, TRMA

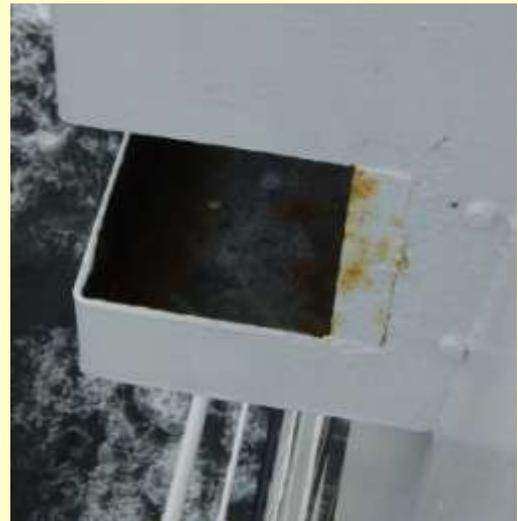
If you're tending toward realism rather than a builder's model, you'll need to add some rust. The ship did have some visible light rust running down the side of the hull a few feet from the expansion joints, the bollards and anchors. This was visible on the *starboard side only* – the port side (facing the pier) was touched up just before sailing day at Southampton. Applying rust calls for a technique called drybrushing, not covered here. The photograph at right shows what rust looks like bleeding through fresh paint, although the rust in question on *Titanic* resulted from water running down from the rusty areas rather than the rust bleeding through. For good illustrations of the rust, see Ken Marschall's paintings in [The Art of *Titanic*](#).)

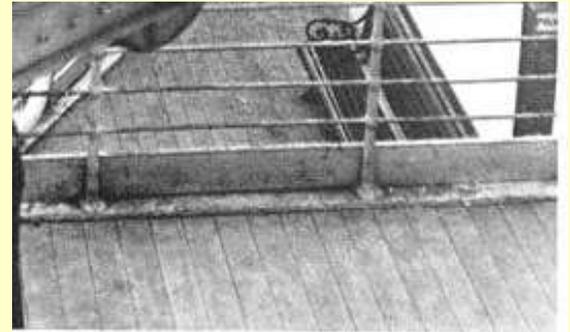
This can be seen around the corners and edges of some of the deck areas and along the washplates at the base of some of the passenger deck railings and would have been present on the funnel casings and deckhouse roofs as well. The Poop Deck, and especially the Forecastle Deck and Well Decks would have also been slightly dirtier as they were working decks. Model railroad weathering powders work well for this, but should *only be used by experienced modelers, and then very sparingly and only after experimenting first on other surfaces to achieve the desired look.* In *Titanic's* case, any weathering or dirt applied should be minimal and just enough to give a realistic appearance without being readily apparent.

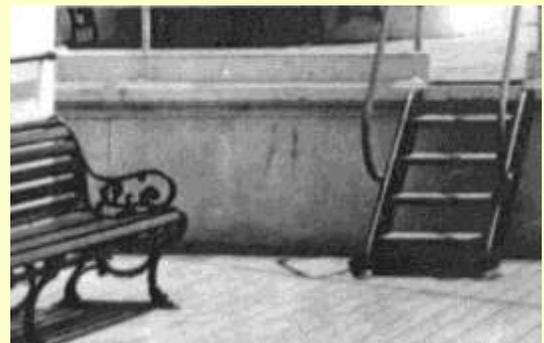
Along the lower areas of the bulwarks (walls) along the outer decks, especially the Well Decks and Boat Deck, there would have been a few marks and scrapes that had not been touched up. Two such marks are visible to the left of the stairs in the photo at right, taken aboard *Olympic* in New York at the conclusion of her maiden voyage. This does not mean that the modeler should intentionally add such marks, but if a tiny smudge or mark results from handling or working on a piece, providing it's low down to the deck it need not be touched up.

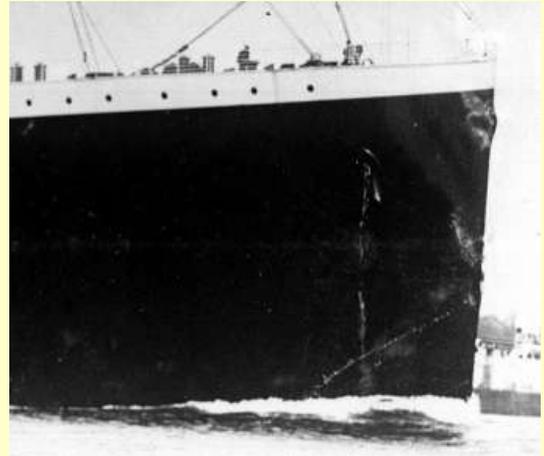
During the near-collision with the New York at Southampton, Captain Smith ordered the starboard bow anchor lowered to the waterline. Photos show a fine light-colored, slightly jagged line where the anchor scraped the black paint of the hull. This can be drybrushed on lightly with flat light-grey paint.

(Note – the diagonal line running from the stem to the waterline is a scratch on the photograph negative. The anchor scrape is vertical and runs from the hawsehole to the white water below.)

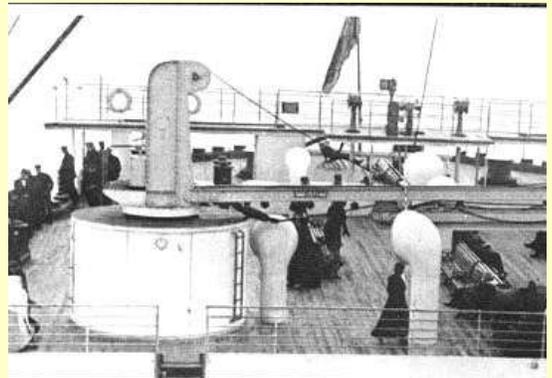
Some modelers interpret the photograph at the right to suggest the possibility that the masts and jibs on the Poop Deck cranes may not have been as white as on the other cranes due to the primer (anti-rust) undercoat partially bleeding through, and possibly because those parts of the Poop Deck cranes had not received their final coat of white. Those suggesting this possibility base it on the slightly darker appearance of the masts and jibs of those cranes compared to their bases, but this is *speculation only* and not a general consensus of the Titanic research community. Modeler's choice; if going this route, the Poop Deck crane jibs and masts (but not the bases) can be painted with the scale white recommended in the Paint Reference, tinted more off-white by the addition of slightly more grey primer.
